Attached please find the "Sub-Slab Depressurization System Final Certification" report dated May 14, 2012, prepared by Aztech Technologies, Inc. This report was prepared as requested by the NYSDOH and the NYSDEC to document the design, installation, and verification testing of the SSDS which was installed at the Magna Metals site at 510 Furnace Dock Road, Cortlandt Manor, NY. The SSDS was installed by and is being operated by the current landowner, Baker Capital, L.P., as requested by the NYSDOH and the NYSDEC.

**Former Magna Metals
Sub-Slab Depressurization System Final Certification**

The following report is intended to present pertinent information and data collected during the pre-design phase and post-installation phase of the sub-slab depressurization system (SSDS) located at the former Magna Metals site (the site) in Cortlandt Manor New York. The purpose of this report is to certify that the SSDS installed at the site is functioning properly and is protective of the occupant's public health. The content below is a combination of data obtained from public records, first hand site inspections and air sampling conducted by Aztech Technologies, Inc. (Aztech).

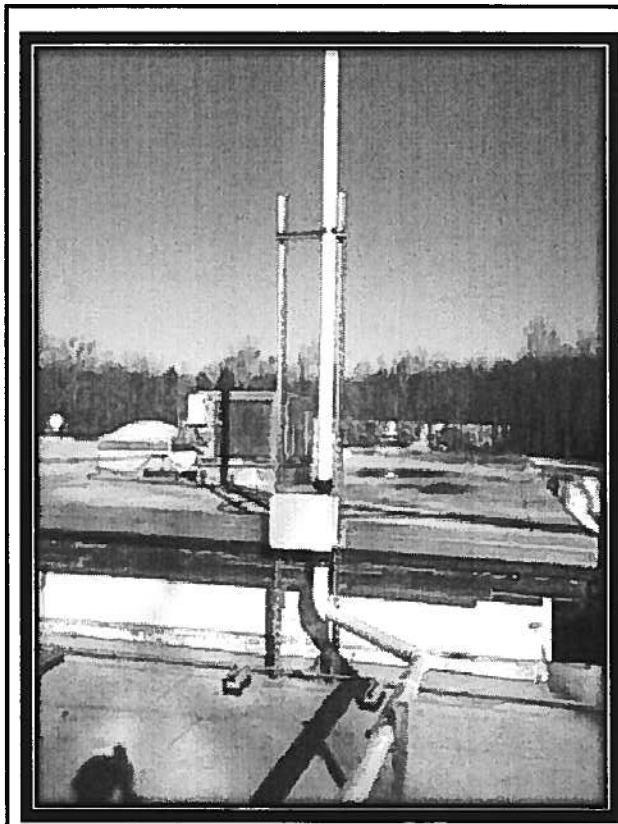
Subject: High Suction Fan

Description: High suction fan mounted to custom bracing on roof with 10-foot high discharge. Power supply mounted to roof directly under fan bracing.

Each of the three high-suction extraction fans have been securely mounted to a custom fabricated steel channel strut bracing directly fastened to the roof. Each fan is powered from a sub-metered electrical panel with dedicated circuit breakers. All labor and materials associated with electrical work was conducted by a certified electrical contractor licensed in the county of Westchester NY.

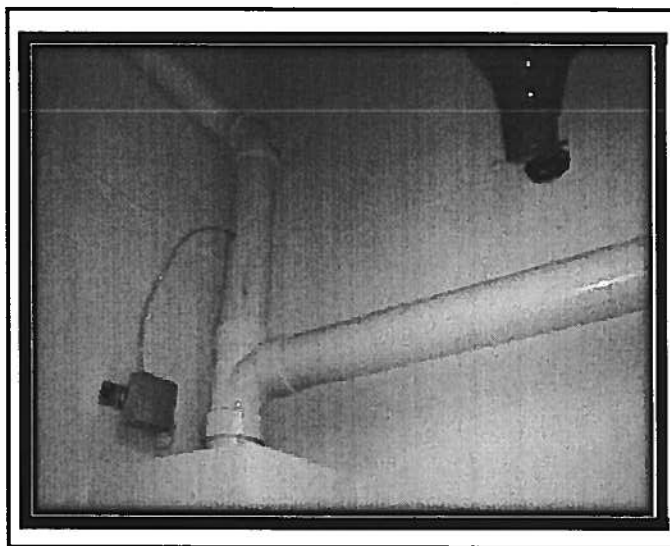
Subject: Header Pipe/Pressure Switch

Description: Extraction wells tied into header pipe. Pressure switch tied into header pipe.

Along each of the three main header pipes, a pressure switch and indicator light have been installed to display when a fan is no longer drawing a vacuum over 0.25 inches of water column. Each indicator light is visible for building maintenance staff to monitor.

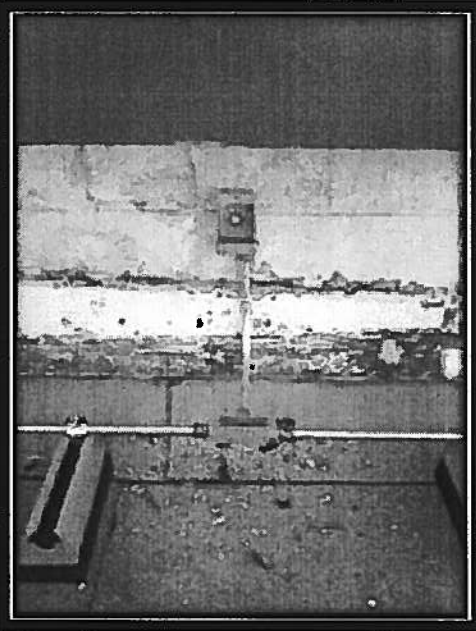
Subject: Roof Conduit

Description: Electrical rigid conduit mounted to roof with junction boxes and liquid tight fittings.

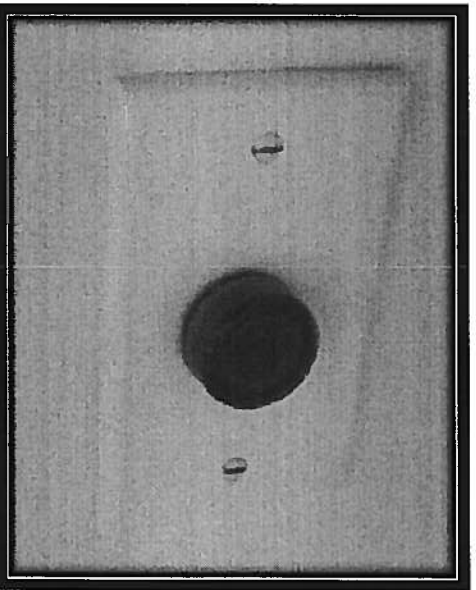
Subject: Pressure Switch Indicator Light

Description: Pressure switch indicator light mounted to wall for easy visibility. If the total vacuum from any of the fans falls below 0.25 inches of water column the indicator light will turn on.

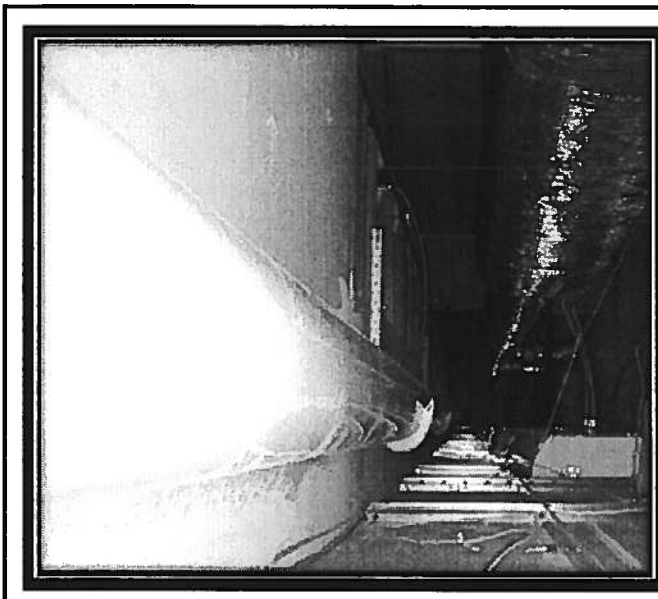
Subject: Lateral Plumbing

Description: Piping installed above drop ceilings were hung on a slight pitch to allow for condensation to flow back to into the wells.

On November 14th 2011, Aztech mobilized a crew of experienced technicians and materials to the site. All extraction wells and lateral plumbing was installed using three-inch (3") Schedule 40 polyvinyl chloride (PVC) pipe and hung above the drop ceiling in the office areas. Each extraction well penetrated the concrete slab and was set at a depth 12-18 inches below the slab. Extraction wells were backfilled with crushed granular stone to allow for an even flow of soil vapor from all directions. A layer of non-shrink grout was placed on top of the stone to ensure a tight seal around the base of the well level with the top of the existing concrete slab. Pairs of adjacent extraction wells were plumbed together into three (3) separate header pipes. Each header pipe penetrated the outer block wall of the building prior to being plumbed up to the roof and into their respective high suction fans. All lateral plumbing was installed sloping back to the extraction wells to prevent condensation from accumulating in the pipe. All condensation will drain back into the ground below the structural slab.

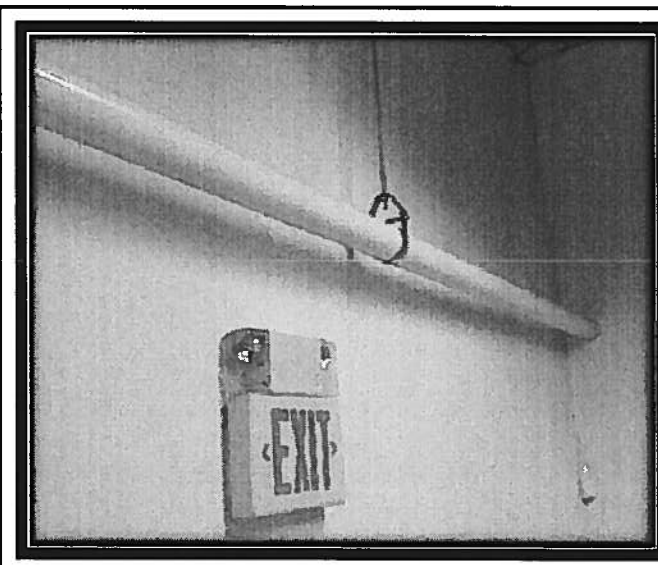
Subject: Exposed Lateral Pipe

Description: Pipe hung in areas of the building without drop ceilings was hung using threaded rod.
